USAAVLABS TECHNICAL REPORT 68-88

T63 REGENERATIVE ENGINE PROGRAM (EXTENDED ENDURANCE AND ENVIRONMENTAL TESTING)

CONTRACT DA 44-177-AMC-293(J)
ALLISON DIVISON, GENERAL MOTORS
INDIANAPOLIS, INDIANA

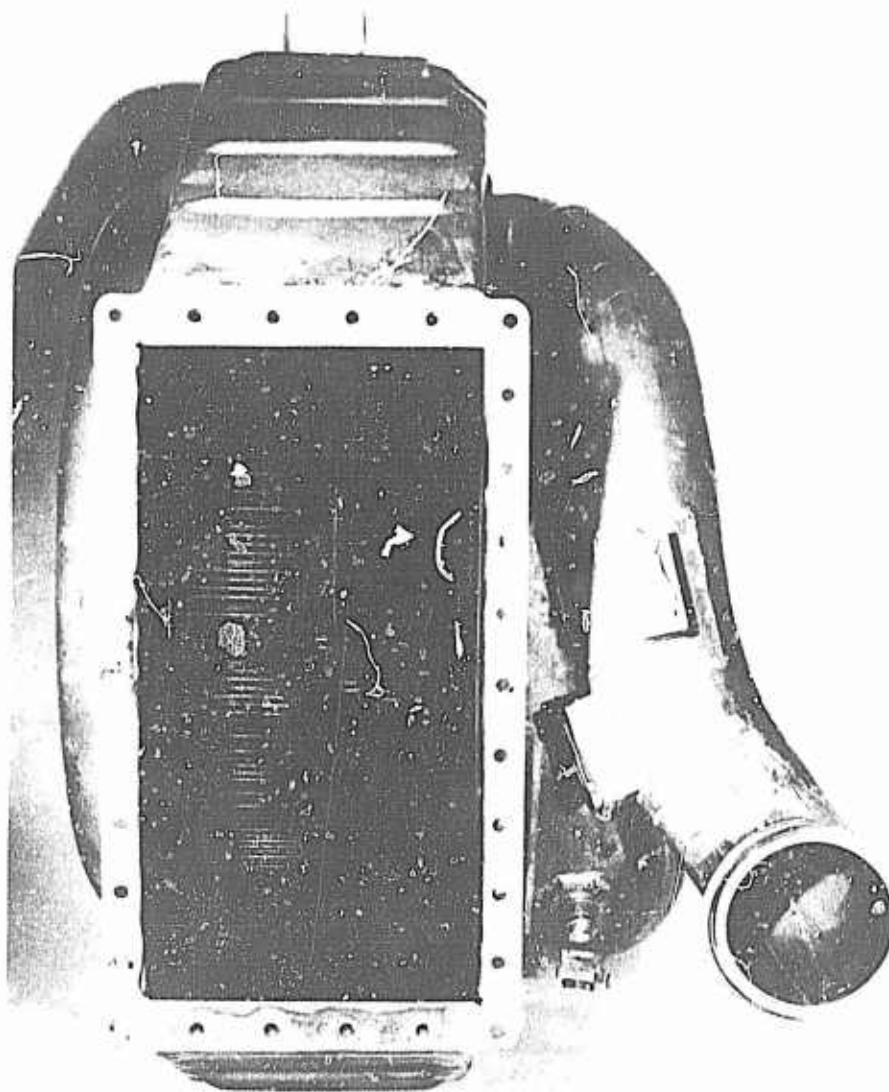
Figure 4. P/N 6858369 Regenerator Prior to 150-Hour Endurance Test.

The regenerators were photographed prior to and after the 150-hour endurance test. At the completion of the test, there was a light deposit of carbon on the tubes but no evidence of buckling of any of the individual tubes in the core. In fact, the carbon deposit was heavier prior to starting the test than it was after the completion of the 150-hour endurance test. The last hour of flight testing consisted of low-power operation, which increases the accumulation of soft carbon. However, the post-endurance calibration was terminated with the maximum power operation. Thus, most of the carbon was burned off. Condition of the regenerator core is shown in Figures 4 and 5.

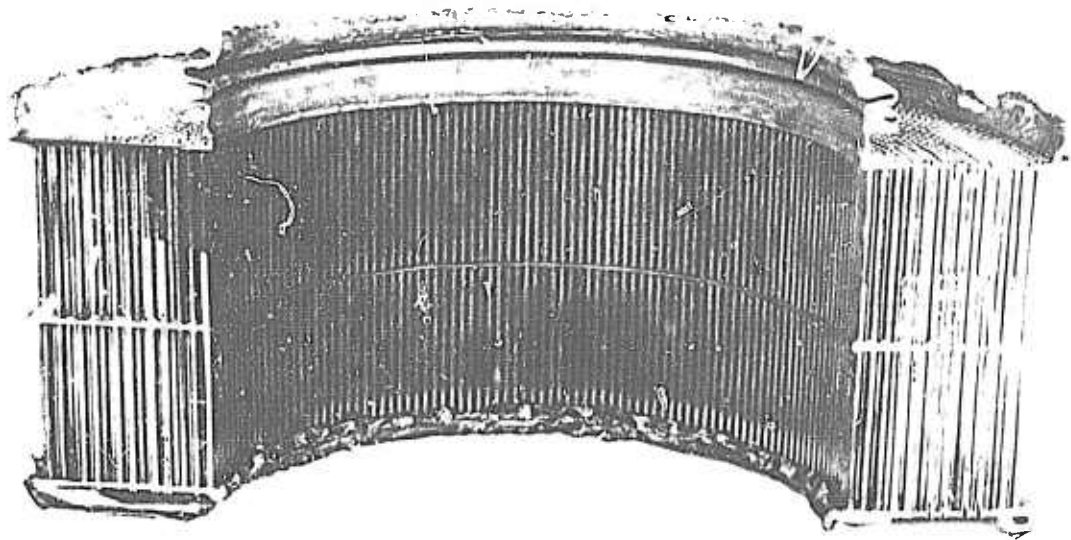
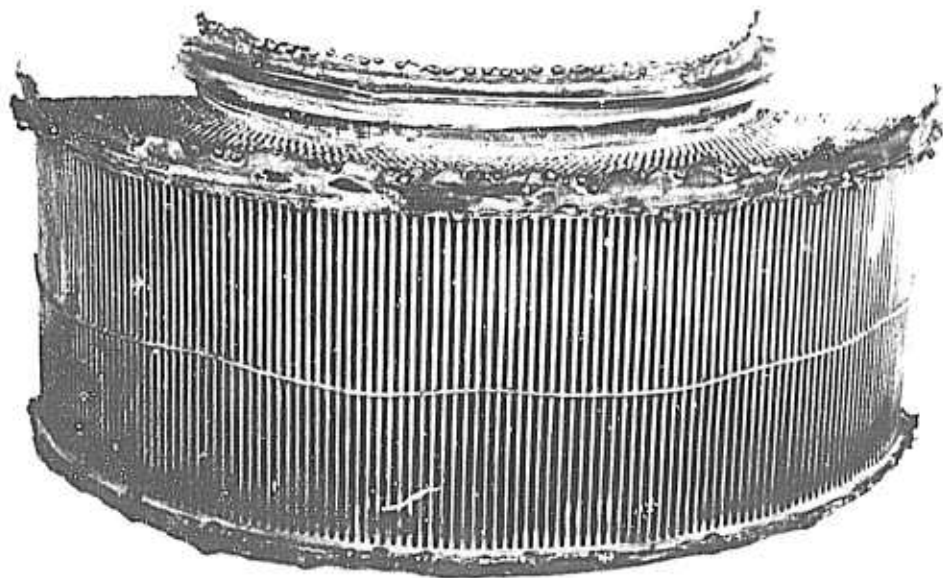
Figure 18. Gas Side of Regenerator Core—First Pass.

Figure 17 defines the regenerator configuration and can be used to locate the areas which were photographed during the metallurgical evaluation. Figures 18 and 19 show the first pass of the regenerator core. There is an indication of surface scale on the outside of the gas inlet tubes, as shown on Figure 18. Most of the dust that had collected on the outside of the gas outlet tubes during the test had been shaken off due to normal handling.
